**CORROSION CONDITION SURVEY  
OF U1020 MONTANA AVENUE OVERPASS-BILLINGS  
FOR  
MONTANA DEPARTMENT OF TRANSPORTATION  
WJE No. 2000.2547  
November 27, 2000**

CORROSION CONDITION SURVEY  
OF U1020 MONTANA AVENUE OVERPASS-BILLINGS  
FOR  
MONTANA DEPARTMENT OF TRANSPORTATION  
WJE No. 2000.2547  
November 27, 2000

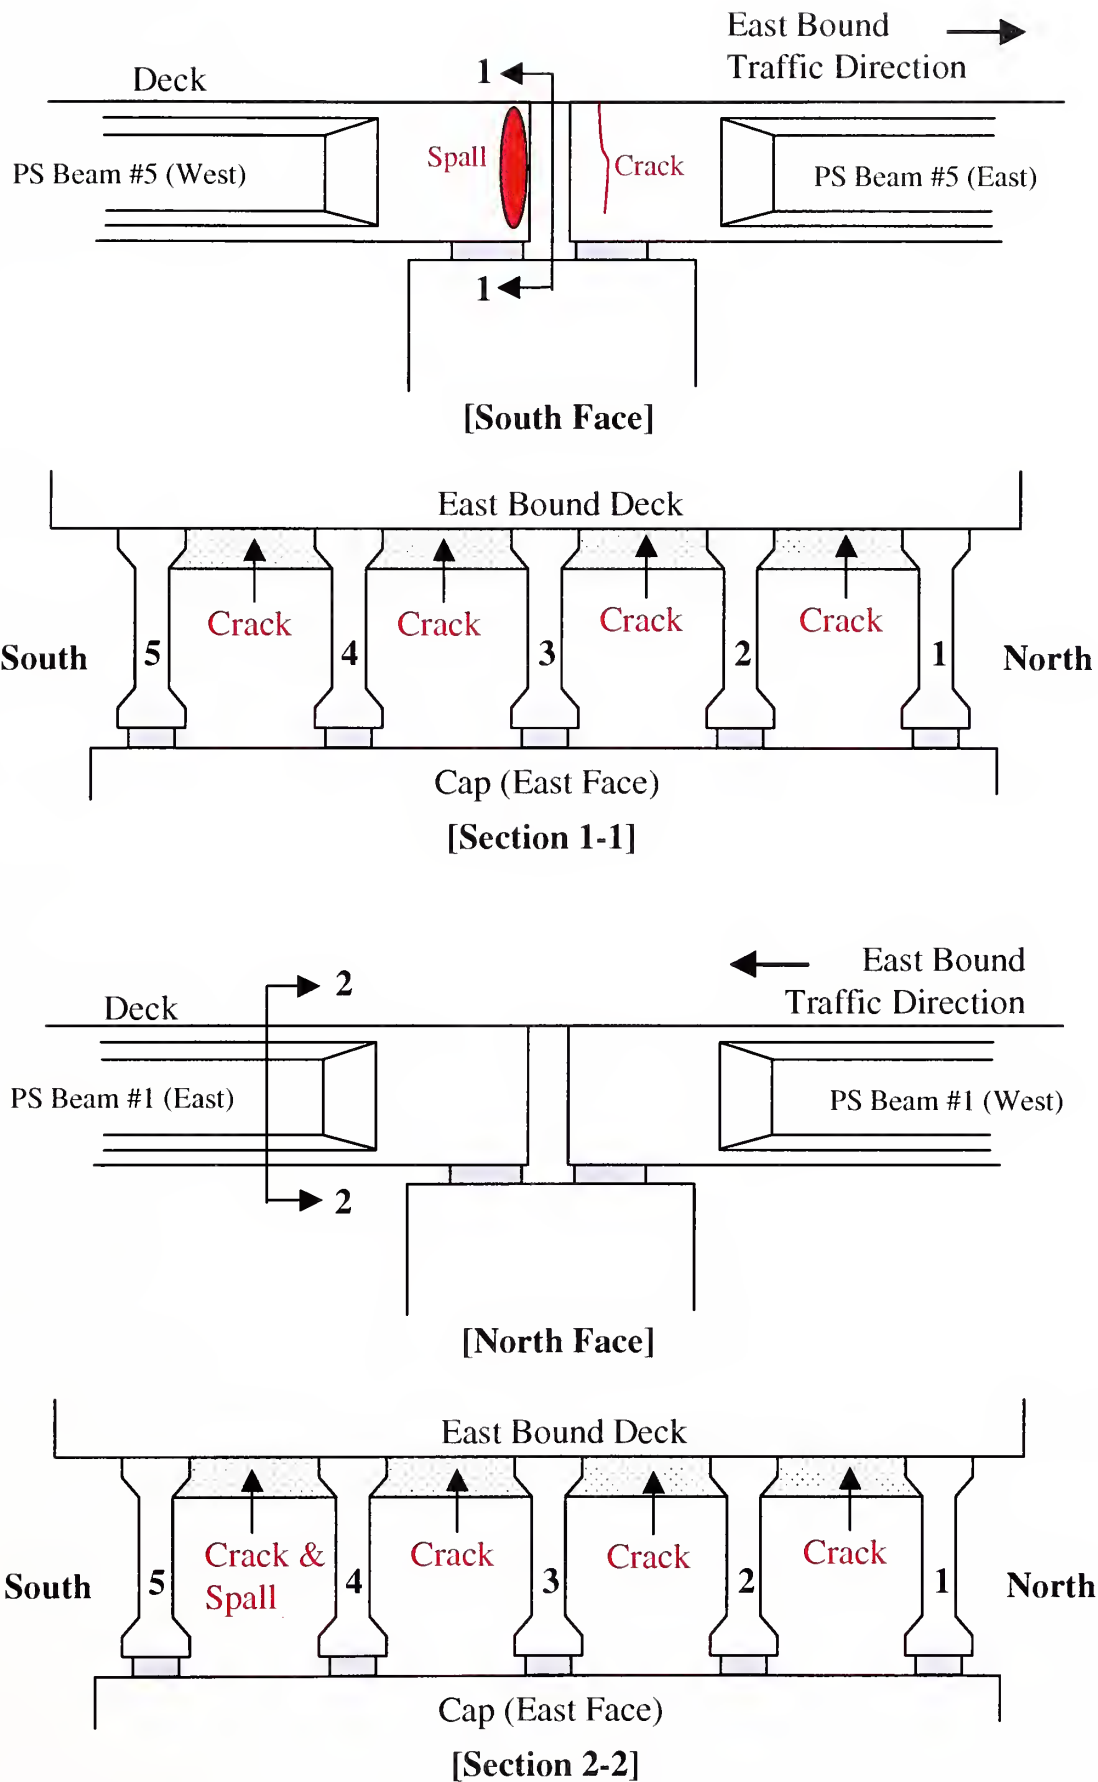
Figure 26B. Condition of Beam Joints over Bent No. 27 (East Bound).

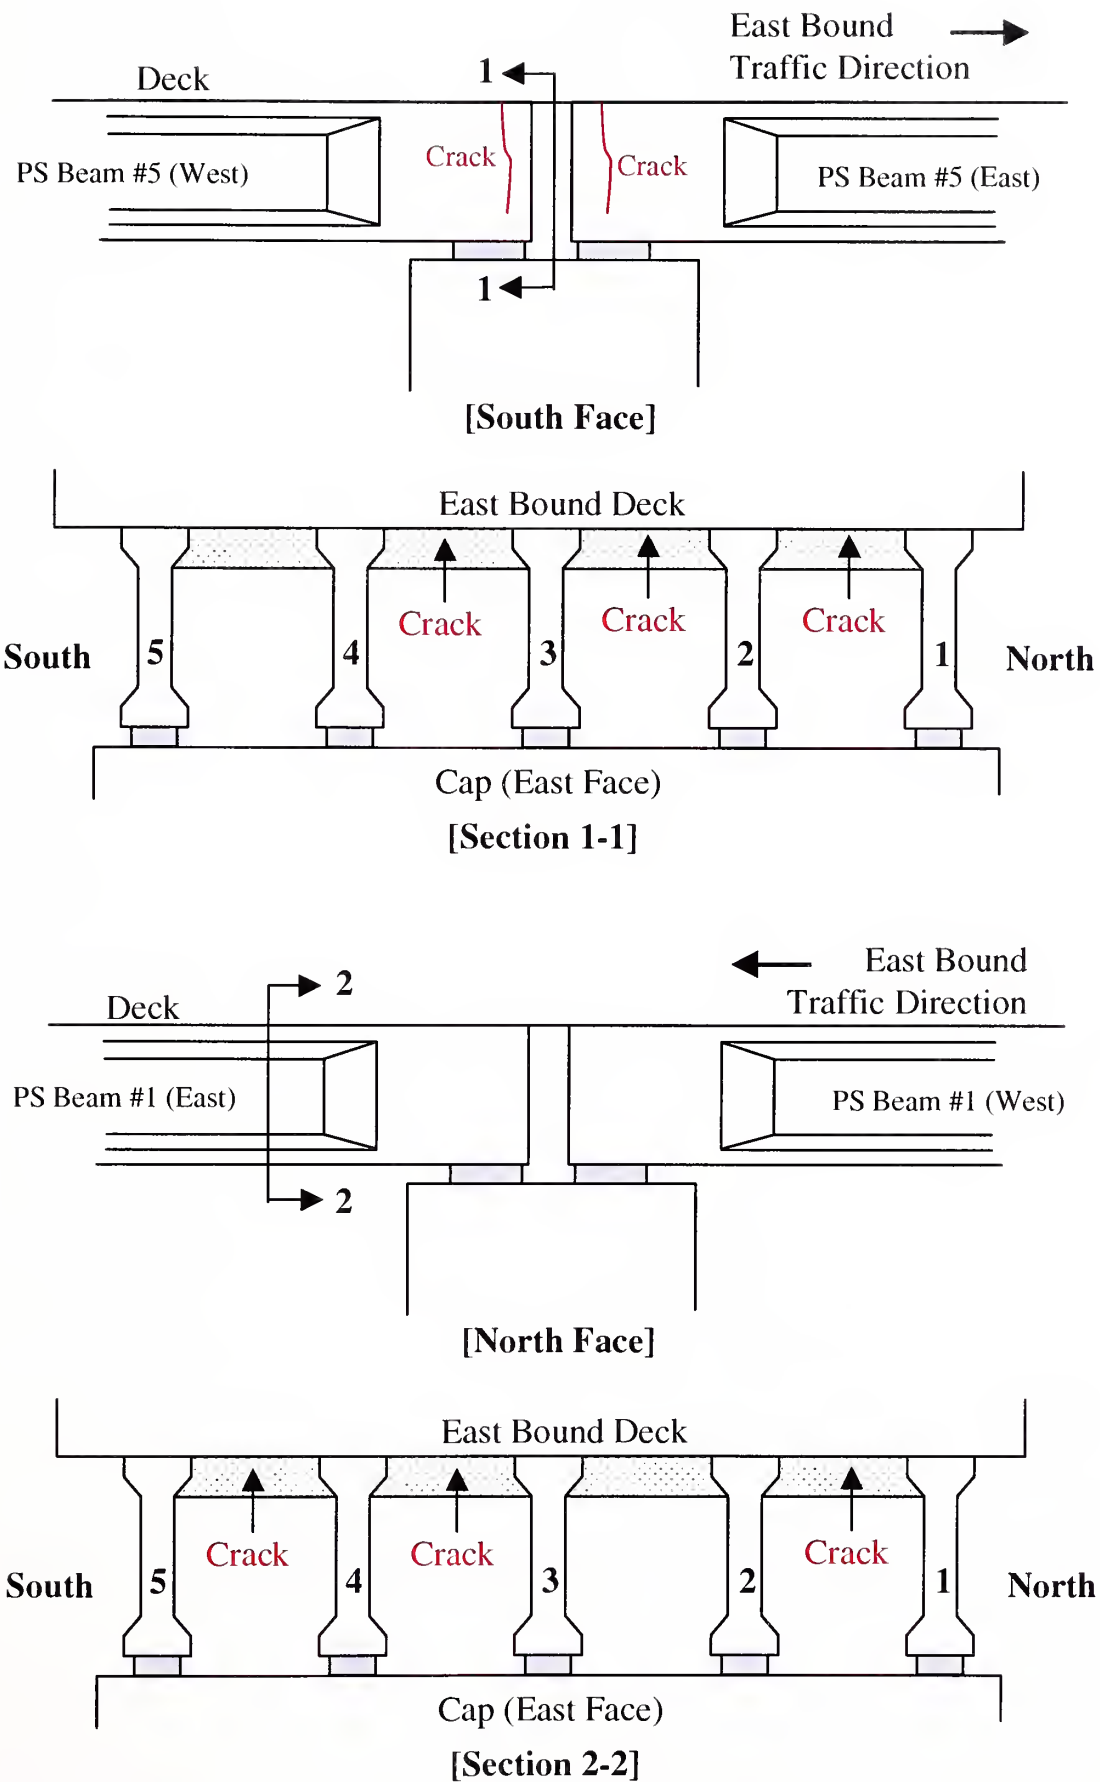
Figure 27B. Condition of Beam Joints over Bent No. 28 (East Bound).

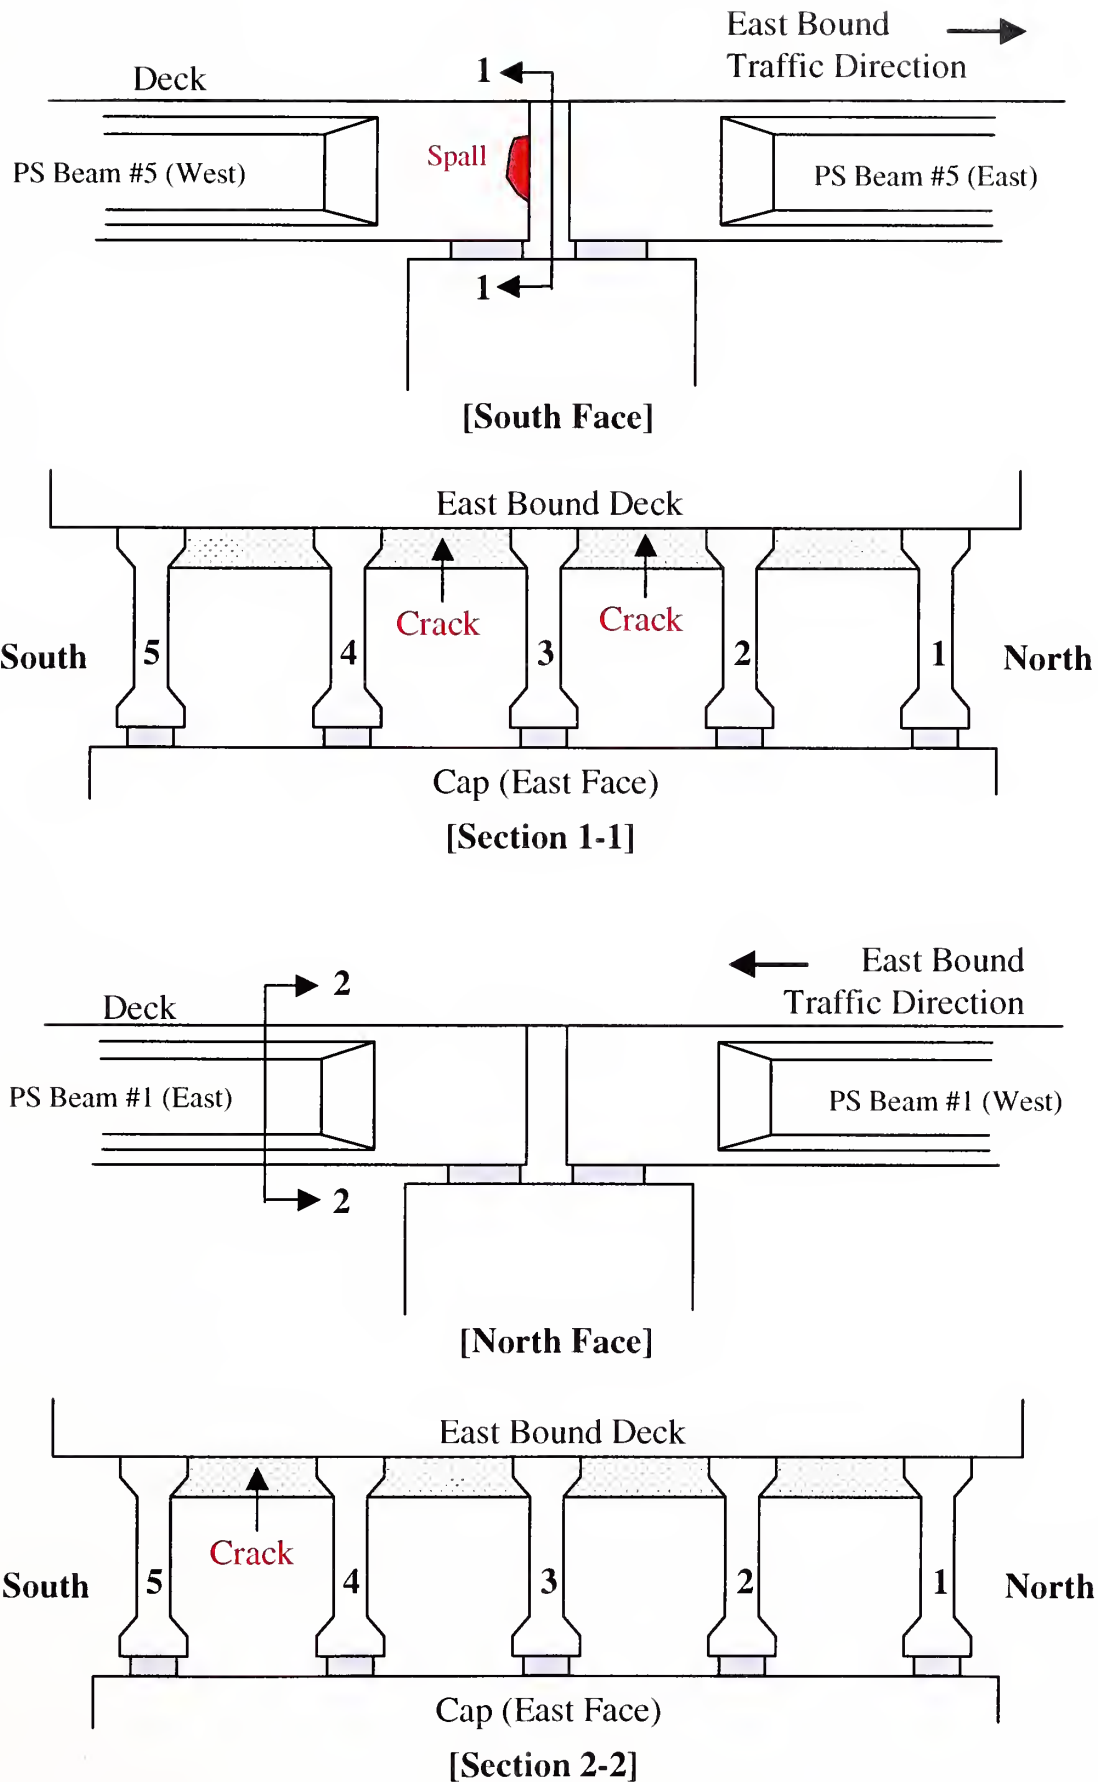
Figure 28B. Condition of Beam Joints over Bent No. 29 (East Bound).

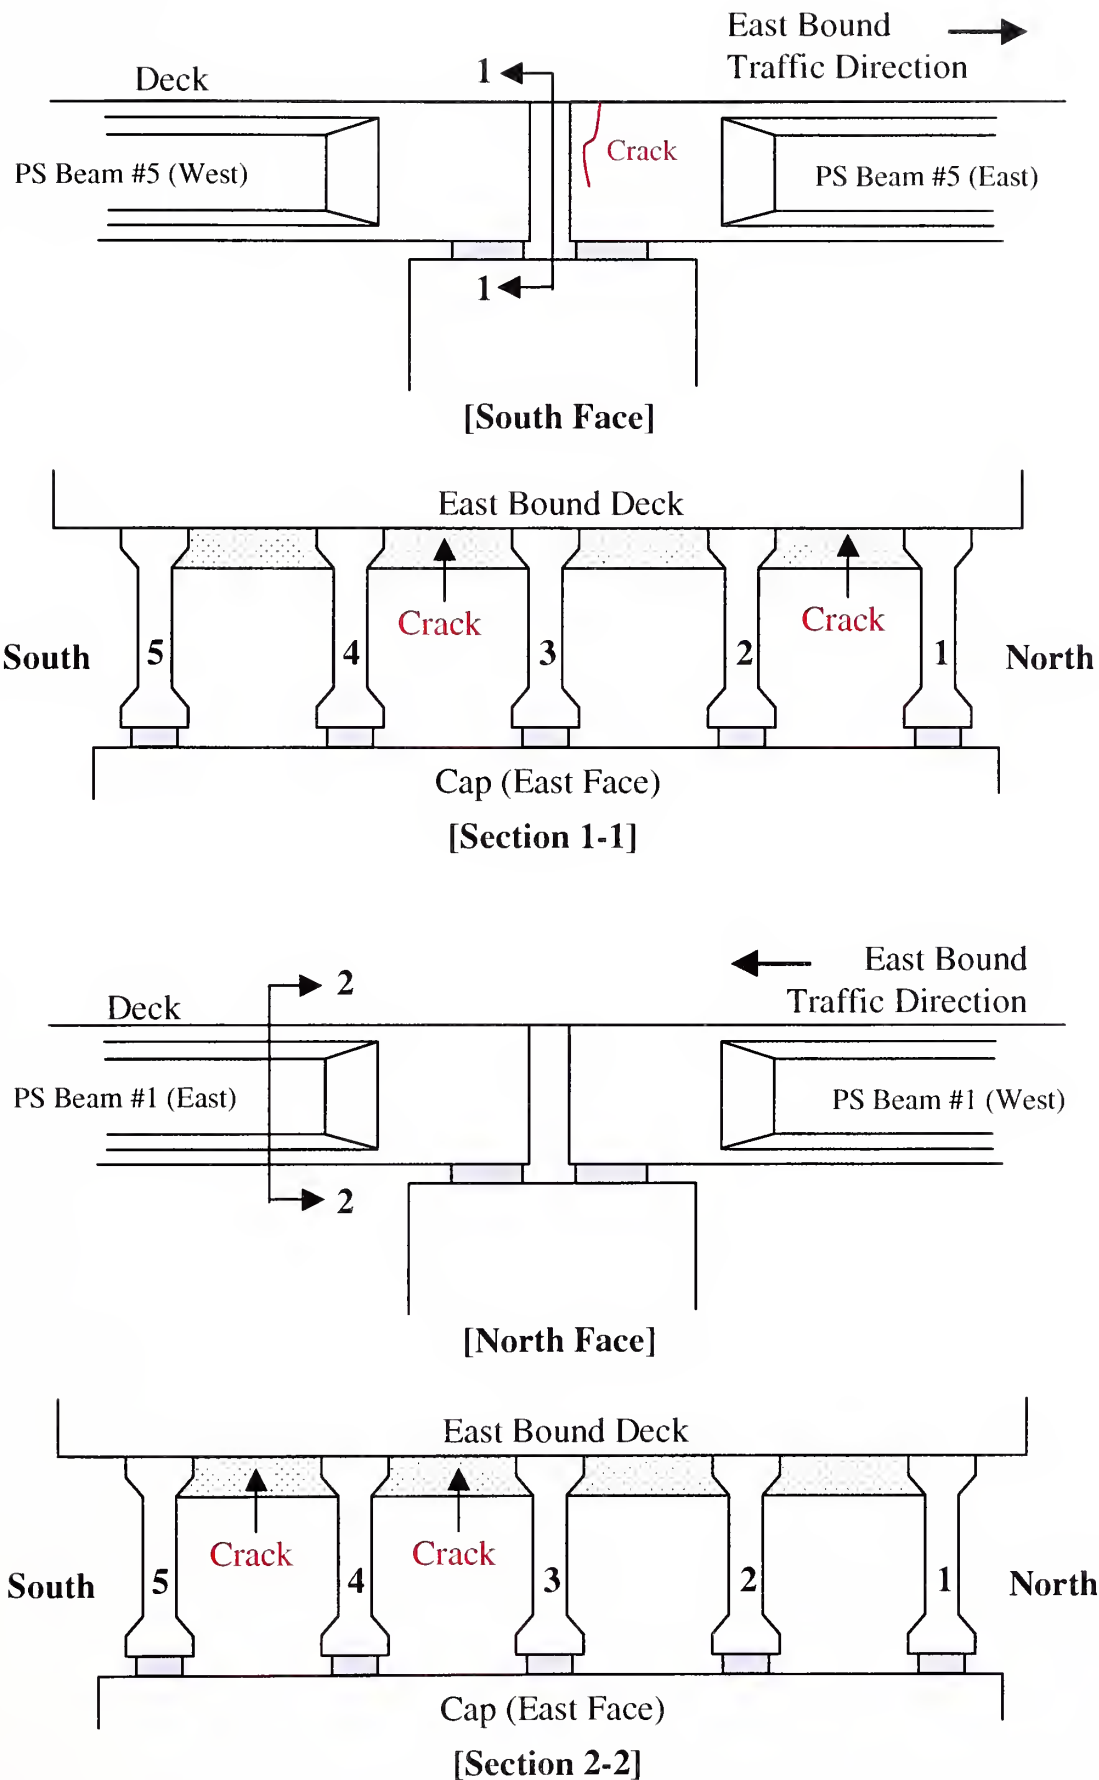
Figure 29B. Condition of Beam Joints over Bent No. 30 (East Bound).

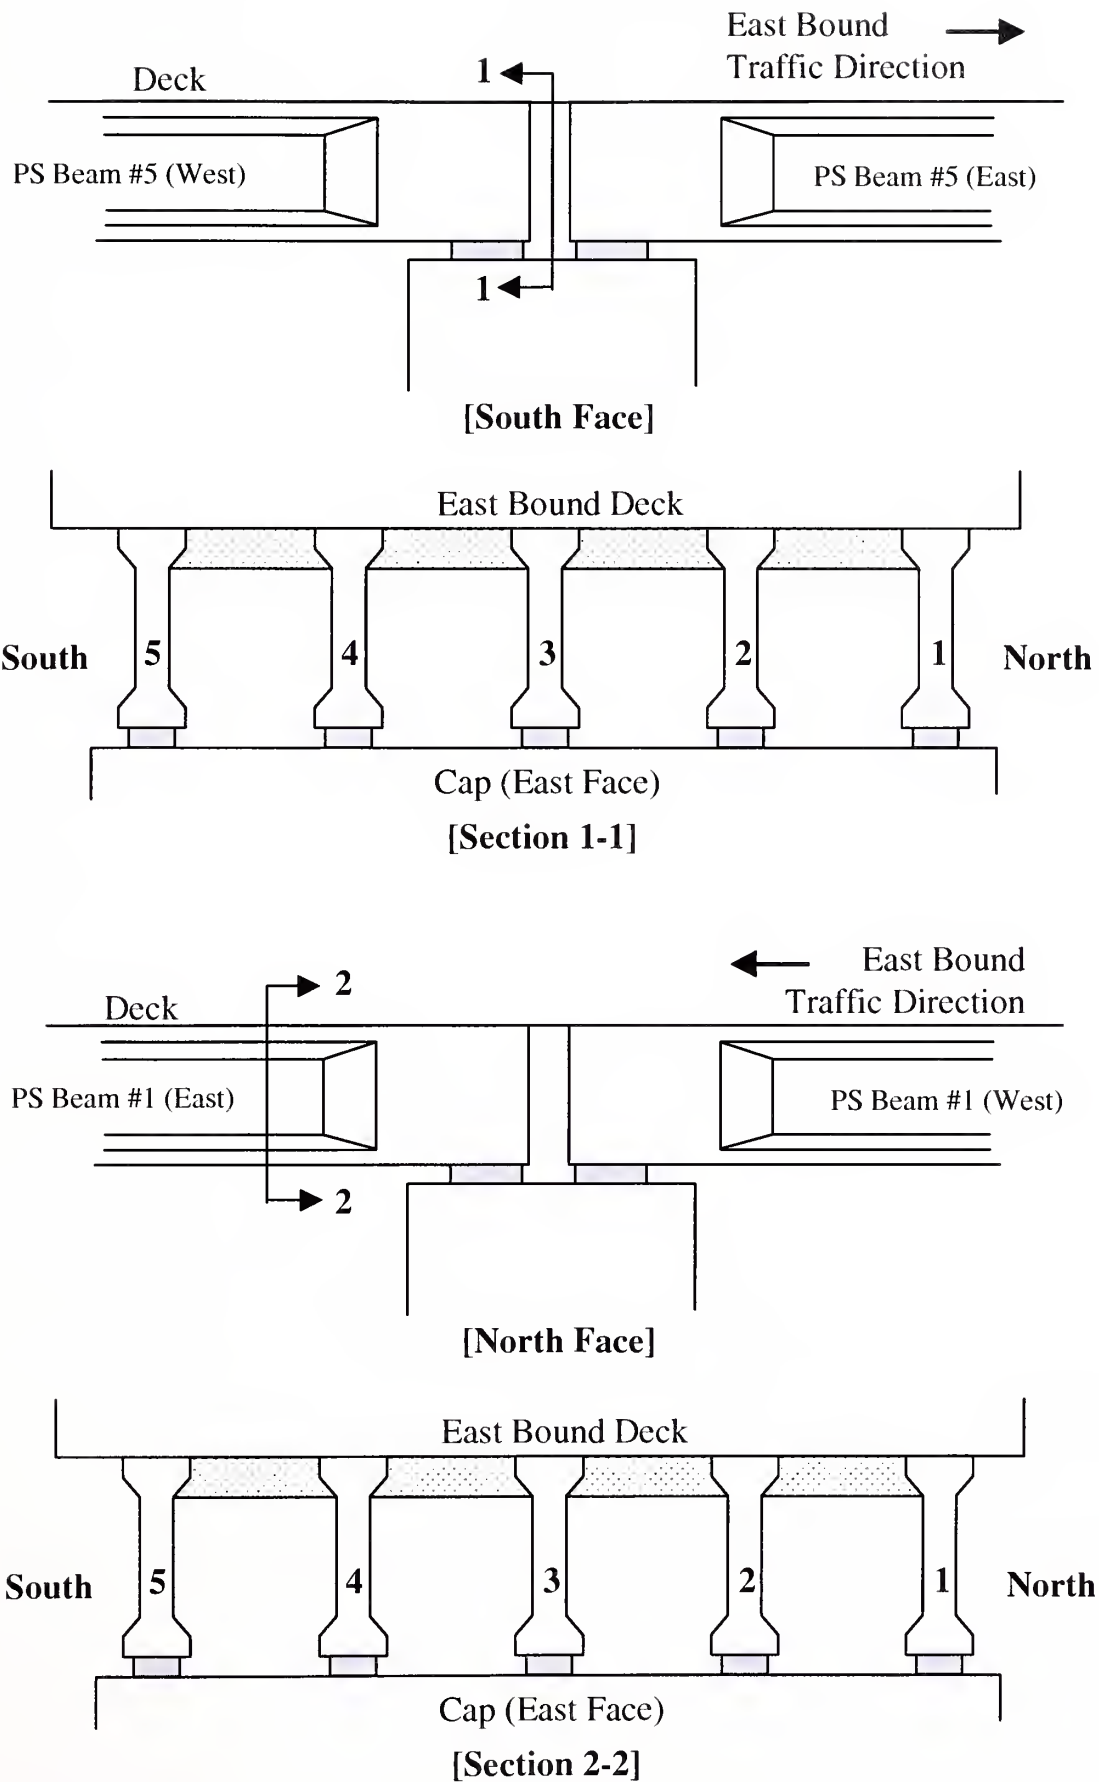
**Figure 30B. Condition of Beam Joints over Bent No.31 (East Bound).**

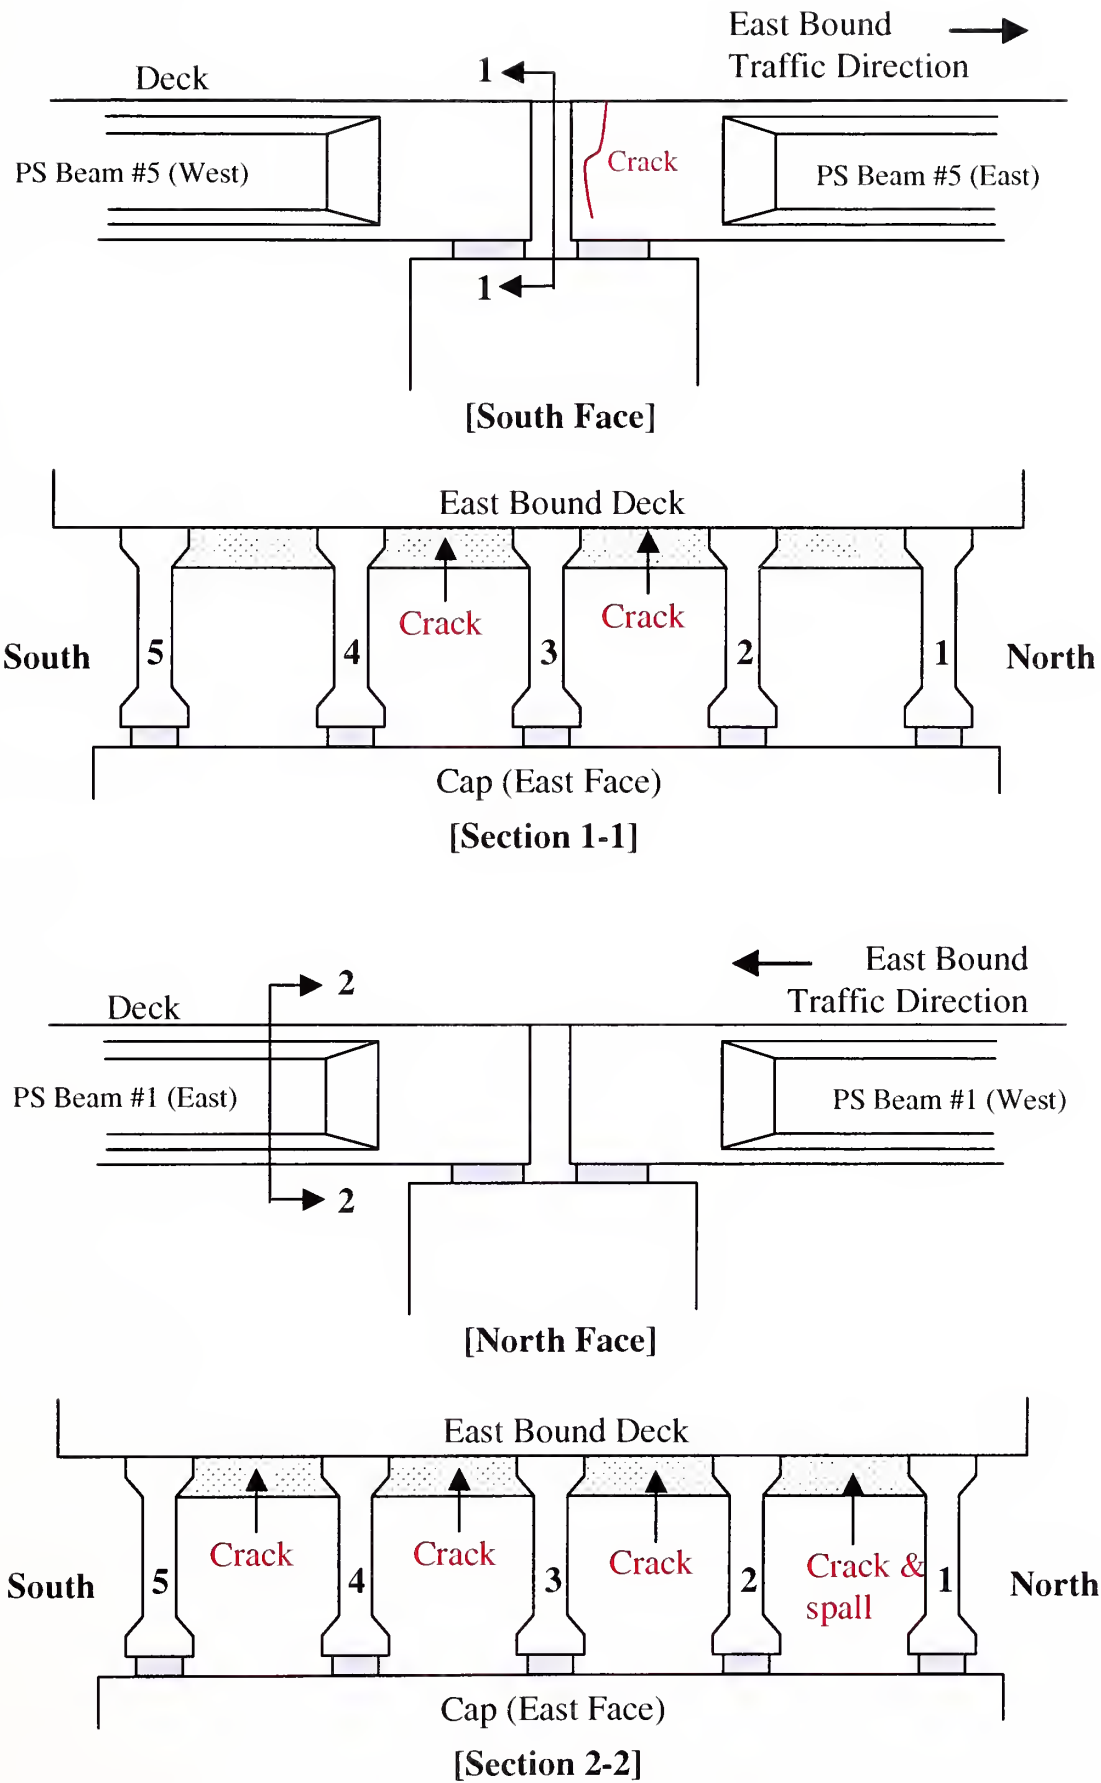
Figure 31B. Condition of Beam Joints over Bent No. 32 (East Bound).

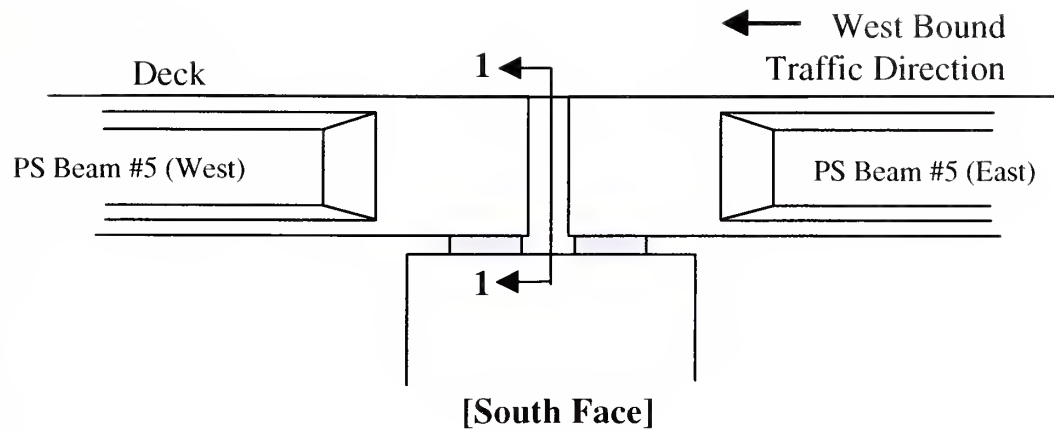
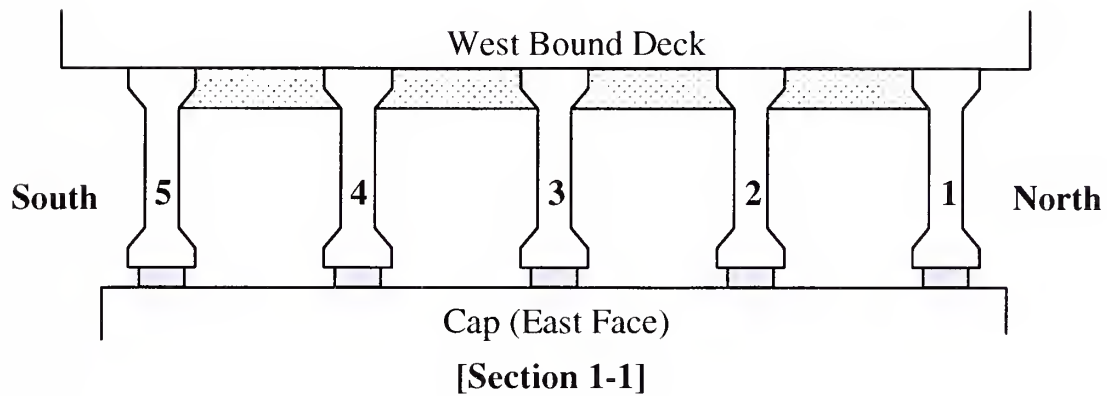
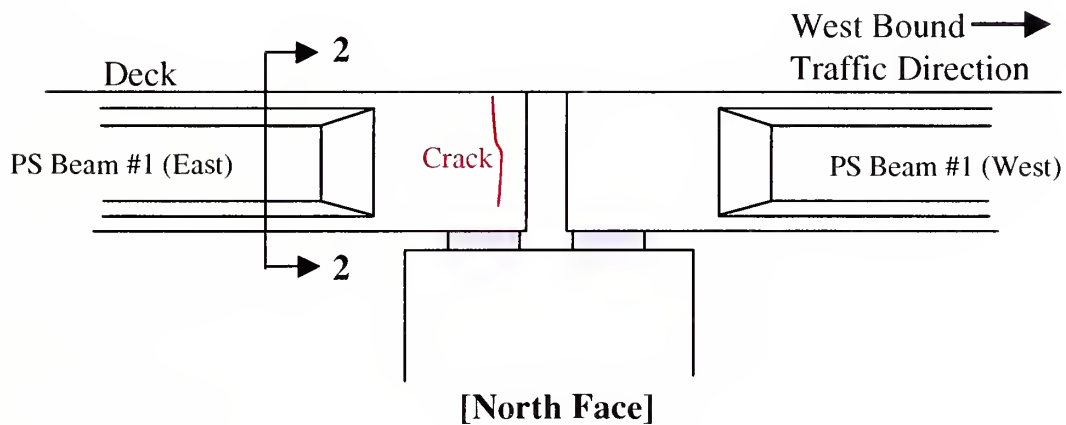
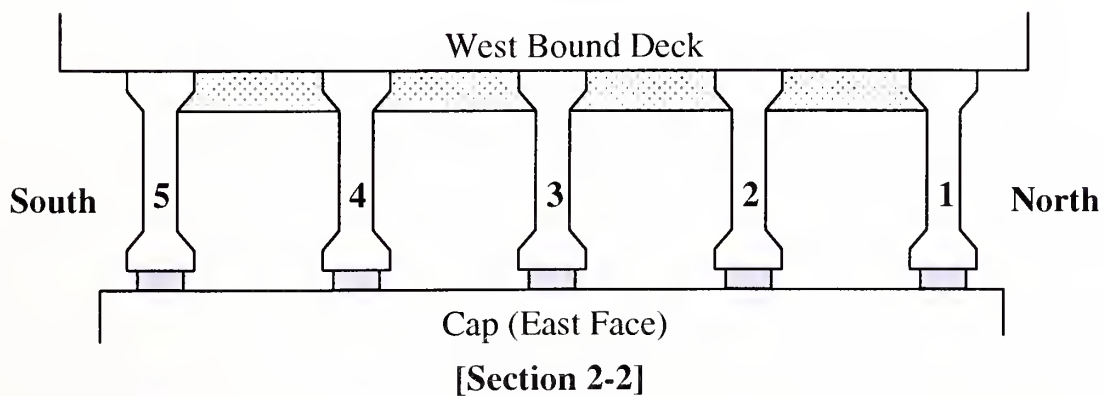
**Figure 32B. Condition of Beam Joints over Bent No. 2 (West Bound).**

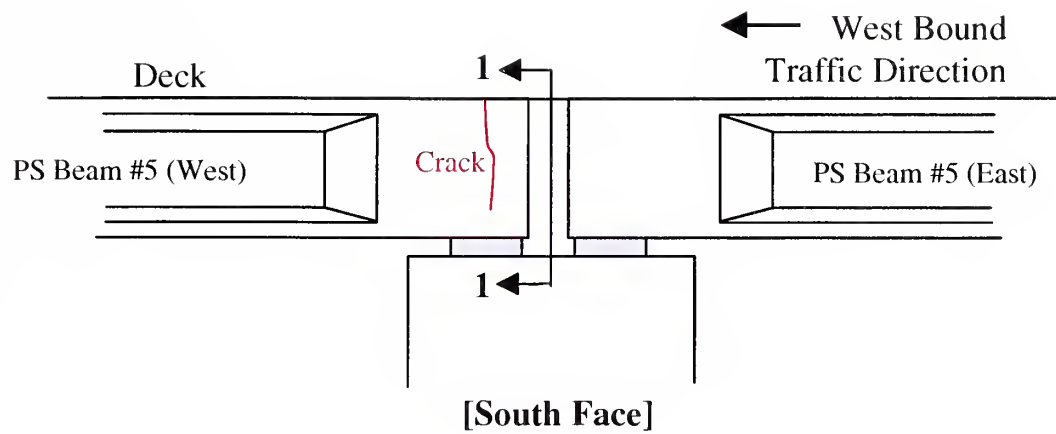
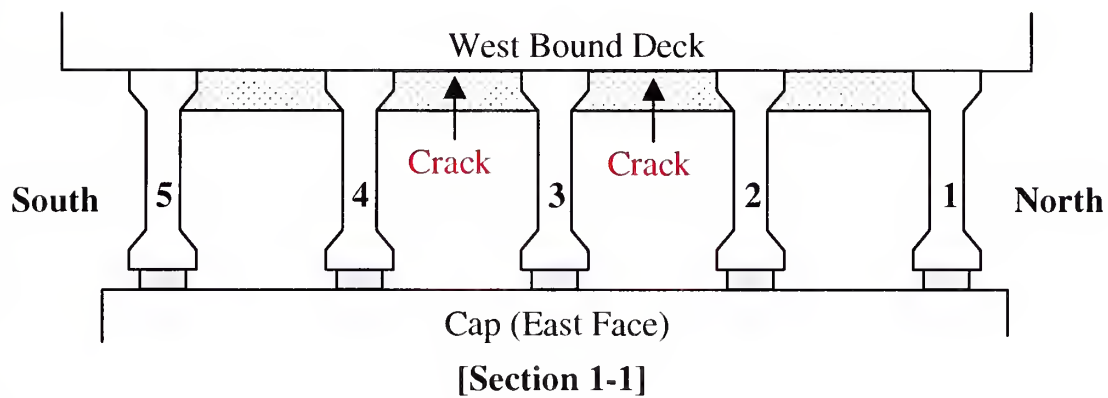
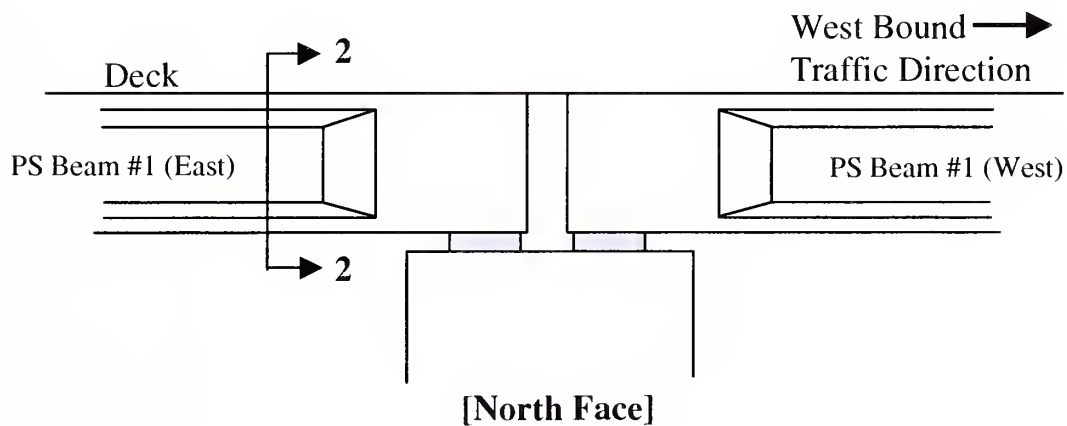
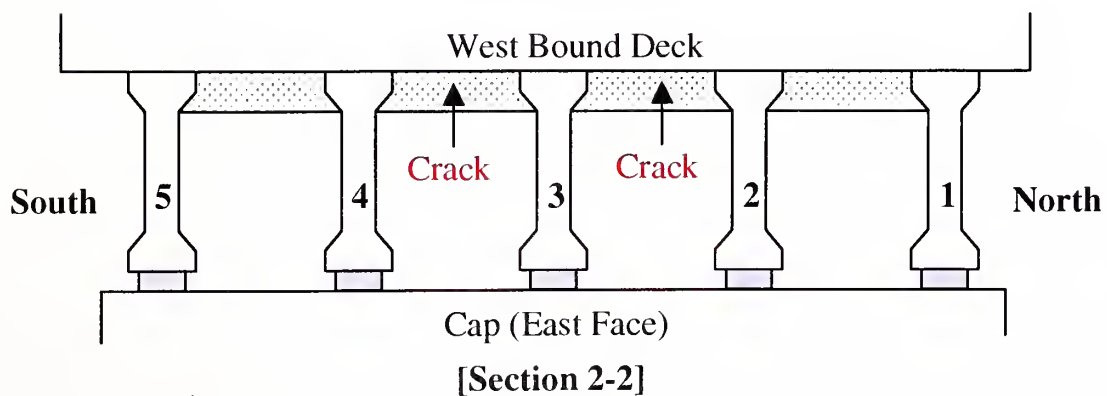
Figure 33B. Condition of Beam Joints over Bent No. 3 (West Bound).

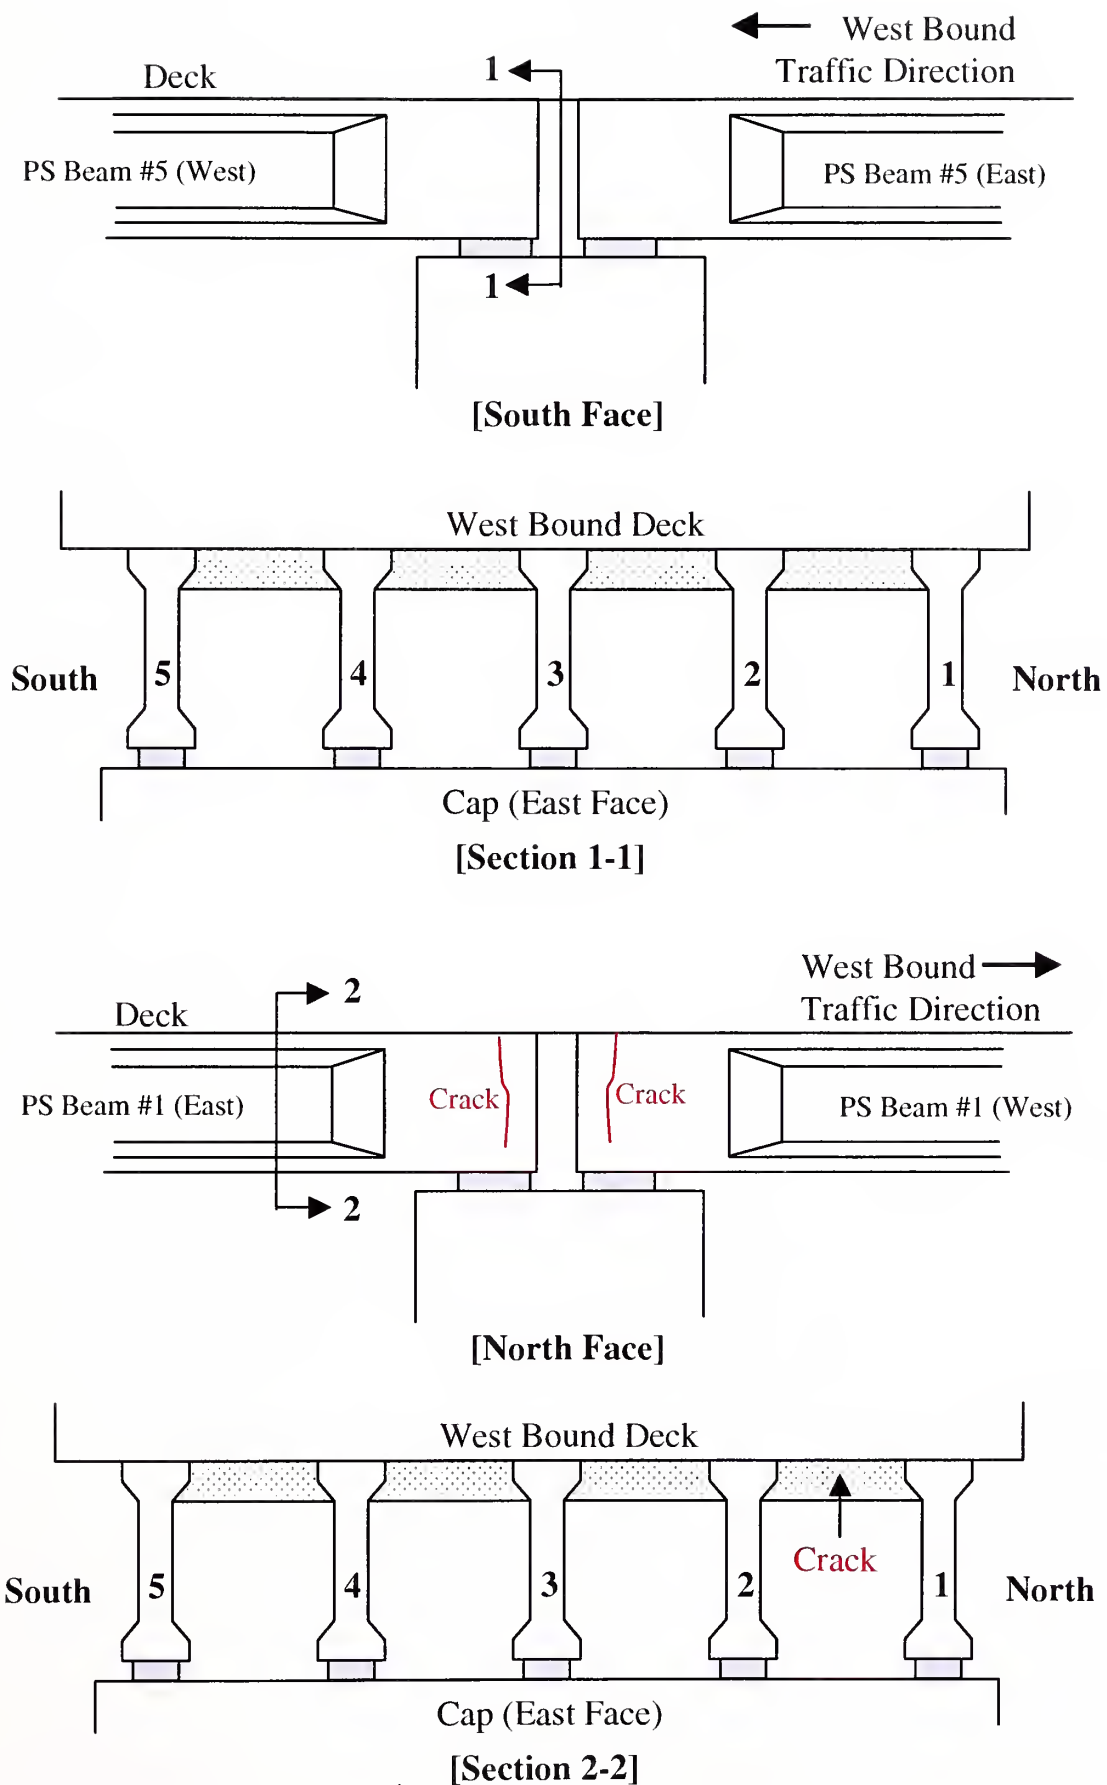
**Figure 34B. Condition of Beam Joints over Bent No. 4 (West Bound).**

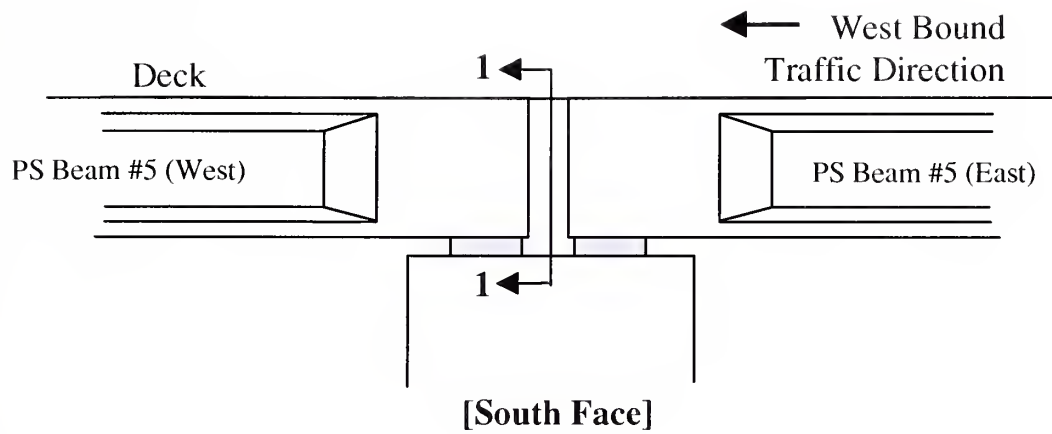
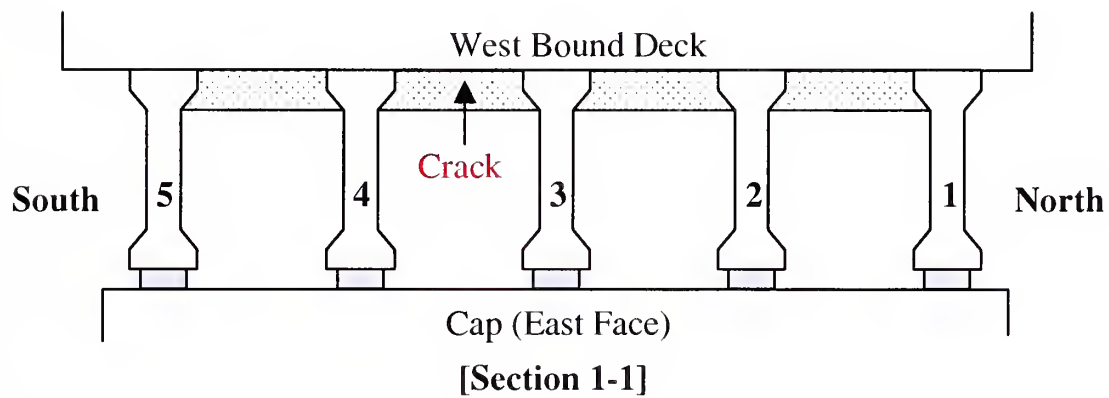
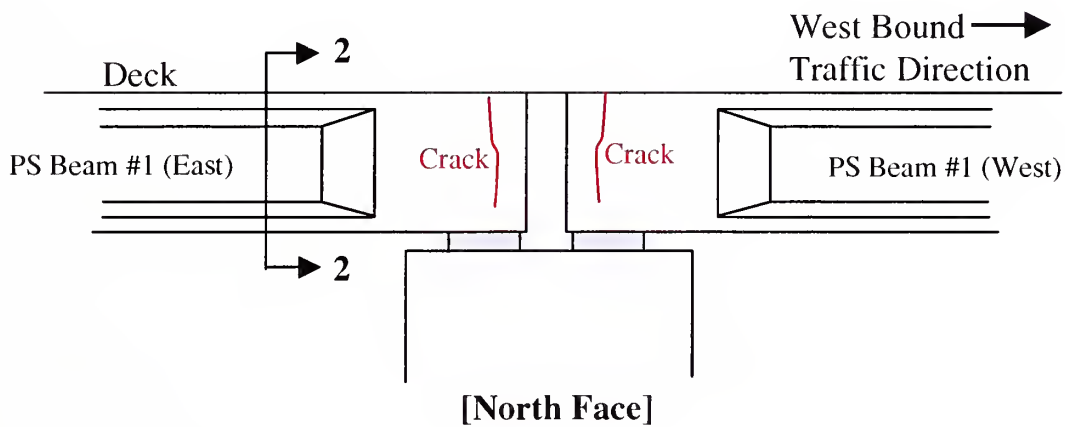
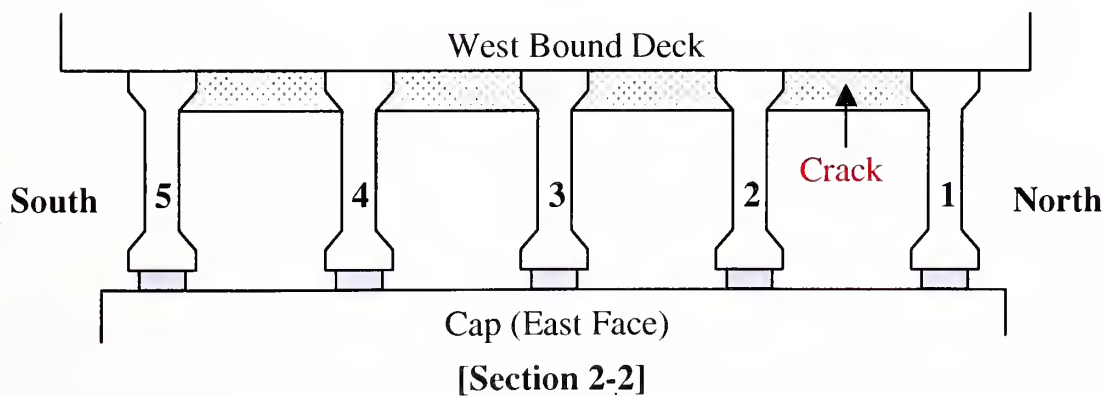
Figure 35B. Condition of Beam Joints over Bent No. 5 (West Bound).

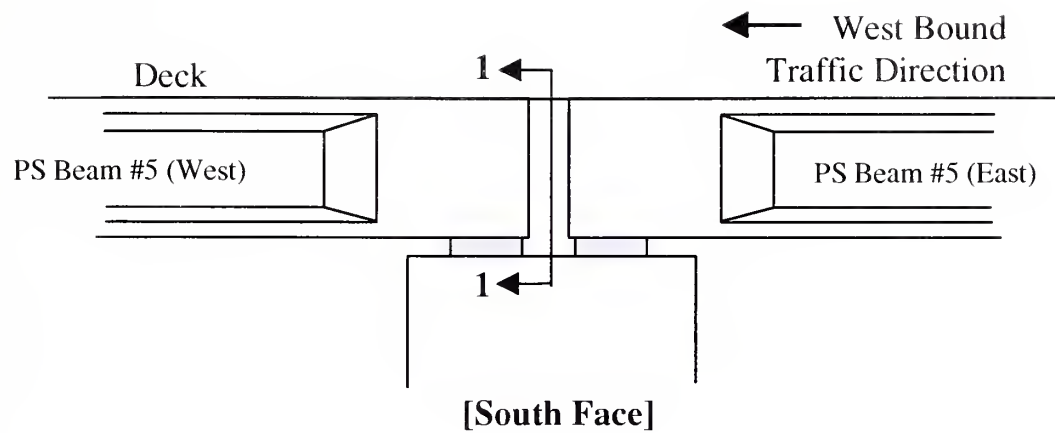
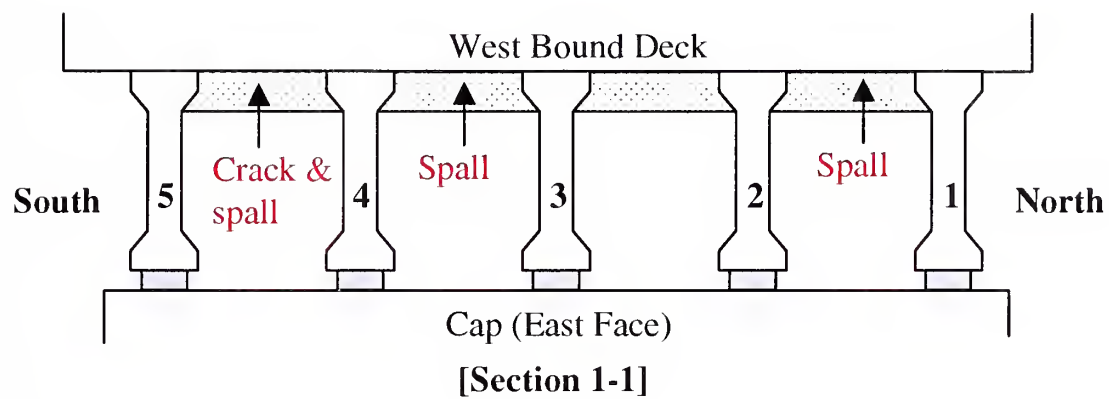
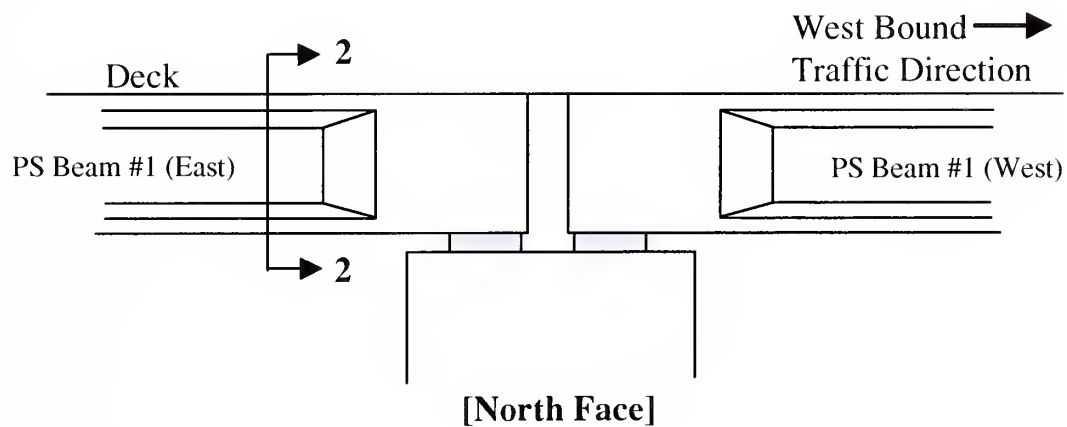
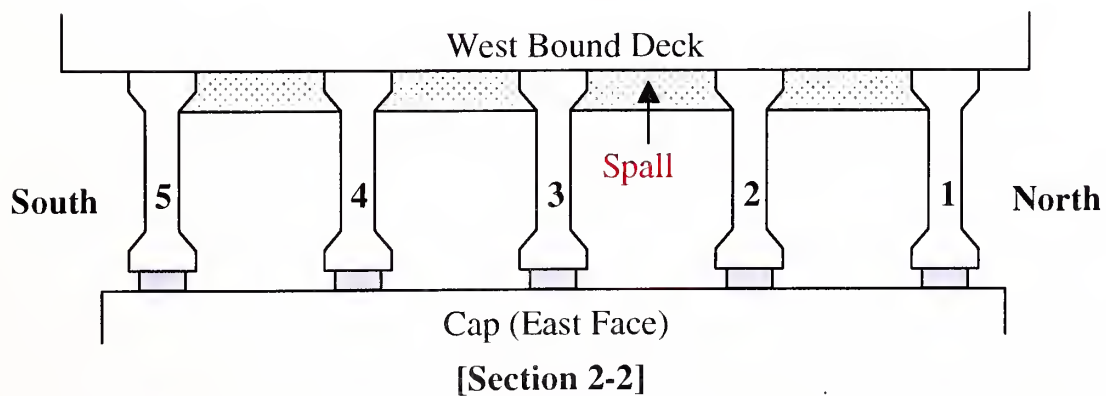
**Figure 36B. Condition of Beam Joints over Bent No. 6 (West Bound).**

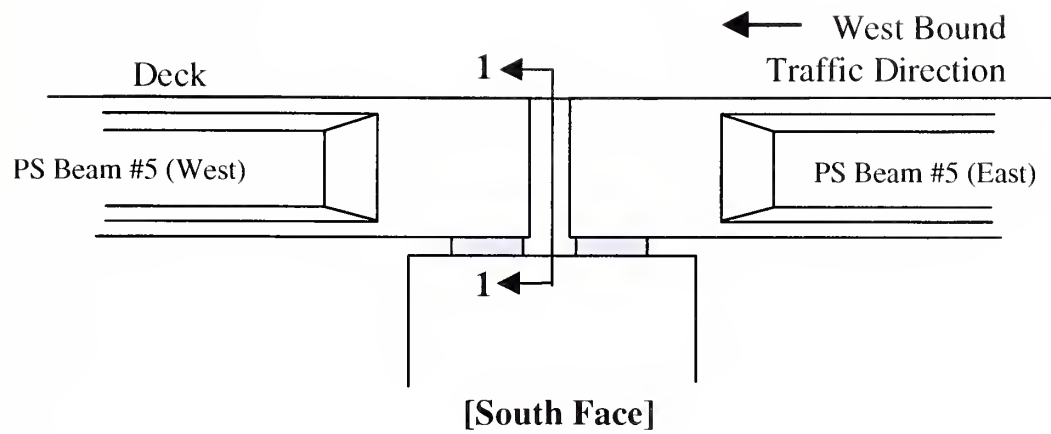
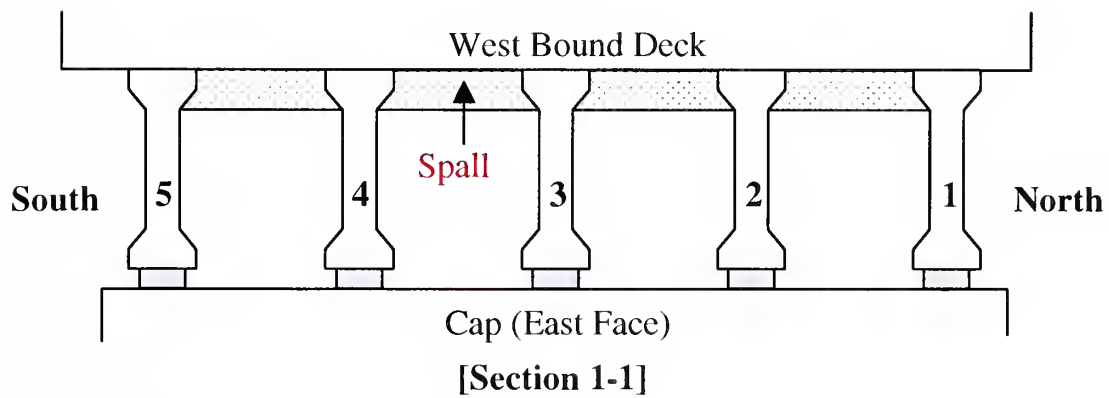
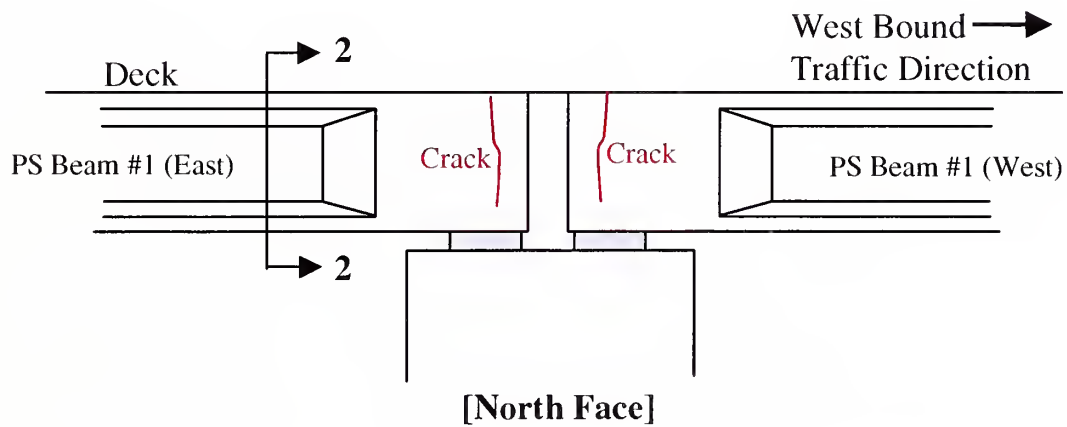
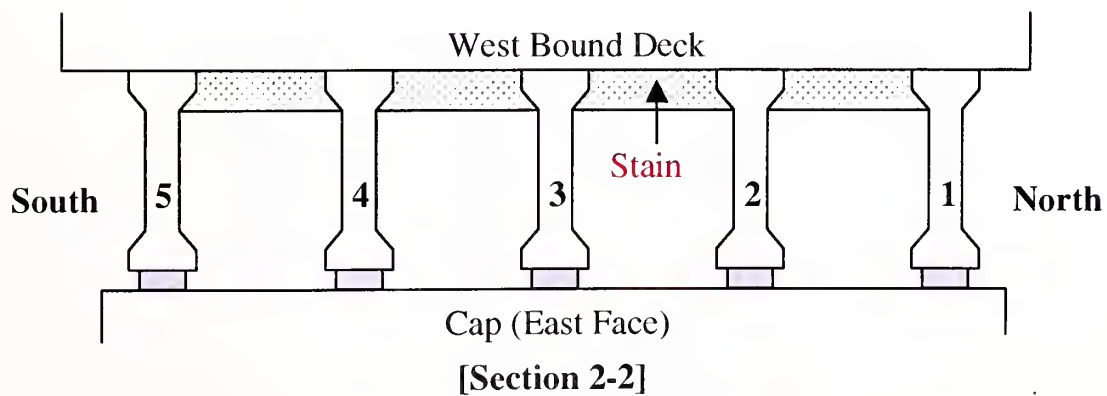
Figure 37B. Condition of Beam Joints over Bent No. 7 (West Bound).
